Performance of IEC 61850 Sampled Values Relays for a Real-World Fault

49th Annual Western Protective Relay Conference, October 2022

Abstract—On September 25, 2021, the Commonwealth Edison Company’s (ComEd) system experienced a catastrophic 138 kV pothead failure near a transition from an overhead line to an underground cable at a 138 kV substation. This section of the line uses an IEC 61850-compliant Sampled Values (SV) bus differential relay (87B23-79DTL) that receives digitized current and voltage values from two merging units (MUs). The 87B23-79DTL relay detected the fault in under 10 milliseconds from the fault initiation and correctly blocked two breaker reclosing relays from any reclosing attempts. An adjacent SV bus differential relay (87B23-2), which is configured to protect the bus section to which this line is attached, properly restrained for this close-in fault.

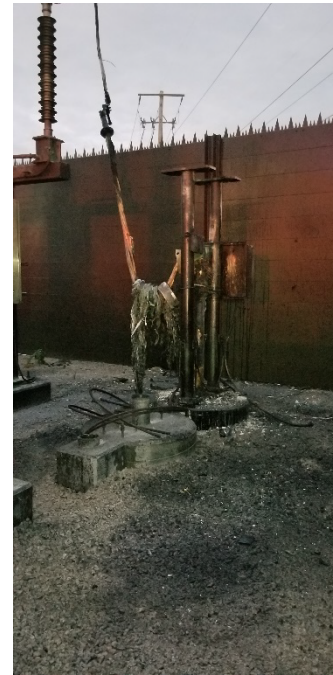
Fig. 1. Damaged overhead-to-underground transition.

On September 25, 2021, an A-phase-to-ground fault at Substation A occurred near a transition from a 138 kV underground cable to an overhead line. A picture of the damage is shown in Fig. 1. An oil-filled pothead that serves as the junction point from the overhead line to the underground line exploded. This explosion threw debris and oil around the surrounding area. Fortunately, no one was nearby when this explosion occurred.

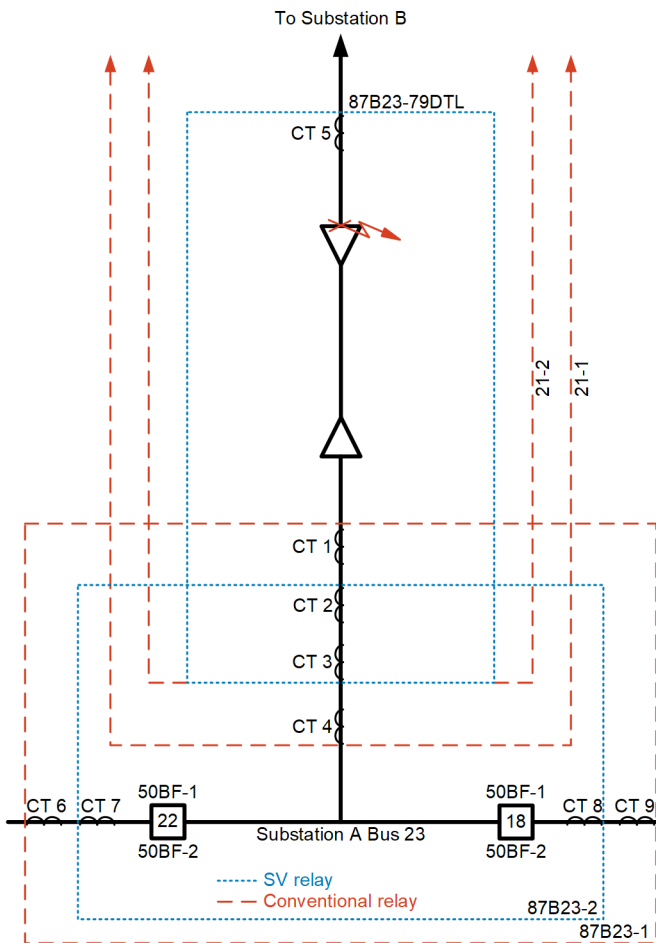
Fig. 2. Simplified protection one-line diagram.

Fig. 2 shows a simplified relaying one-line diagram with the location of the fault marked. The Substation A to Substation B line is a radial line (there is no fault current contribution from Substation B). There are five separate relays that respond to this fault and are described with their relay type, function, and the current transformers (CTs) they acquire analog data from in Table I. All relays in Table I are made by Manufacturer A.

For this fault, Relays 21-1, 21-2, and 87B23-79DTL operated and Relays 87B23-2 and 87B23-1 restrained. This is the expected and correct operation for all relays. In the next subsections (A through C), we analyze the events provided by the relays in more detail.

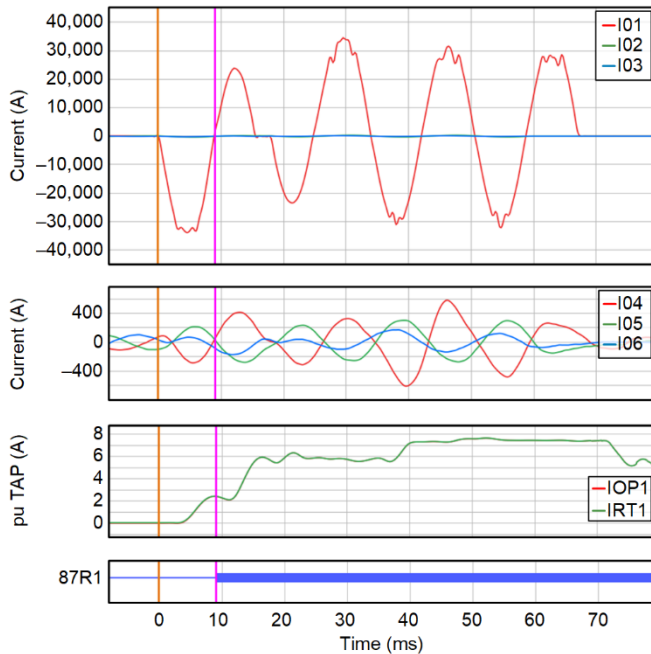
Fig. 3. 87B23-79DTL event.

The unfiltered event report data, sampled at 2 kHz from the 87B23-79DTL relay, are shown in the top two graphs in Fig. 3. The Substation A contribution (I01, I02, I03 from CT 3) to the fault is significant with peak current values higher than 30 kA. In contrast, the Substation B terminal produces no fault current contribution (I04, I05, I06 from CT 5), but some load is connected to the line. The 87B23-79DTL relay is a low-impedance bus differential relay that vectorially adds the filtered current contribution from the two three-phase current sources to produce an operate current (IOP1, IOP2, and IOP3). The relay also adds the magnitude of the two three-phase current sources together to create a restraint current (IRT1, IRT2, IRT3) using filtered current. For this A-phase-to-ground fault, there was very little current flowing in the unfaulted phases, and we plotted only the A-phase operate magnitude and restraint magnitude (IOP1 and IRT1) on the third graph. IOP1 and IRT1 are equal.

The IOP1 and IRT1 signals are scaled by the CT ratio settings and additional TAP scaling settings available in the relay. The CT ratio is 600:1 and the TAP scaling for all terminals is 5. All primary current values are divided by 3,000 ($600 \cdot 5$). This puts the IRT1 and IOP1 signals in per unit (pu) of the TAP setting.

The ratio of operate current over restraint current (measured in percentage) is 100 percent, because IOP1 equals IRT1. For an operation to occur, the relay was set such that the ratio of operate current over restraint current had to exceed 60 percent. This requirement was met, and the relay was able to operate within 9 milliseconds of fault inception (87R1 assertion). Upon operation, the 87B23-79DTL relay sent a GOOSE message to 50BF-1 and 50BF-2, which are the breaker control relays at Breakers 22 and 18 to prevent reclosing on the underground section.

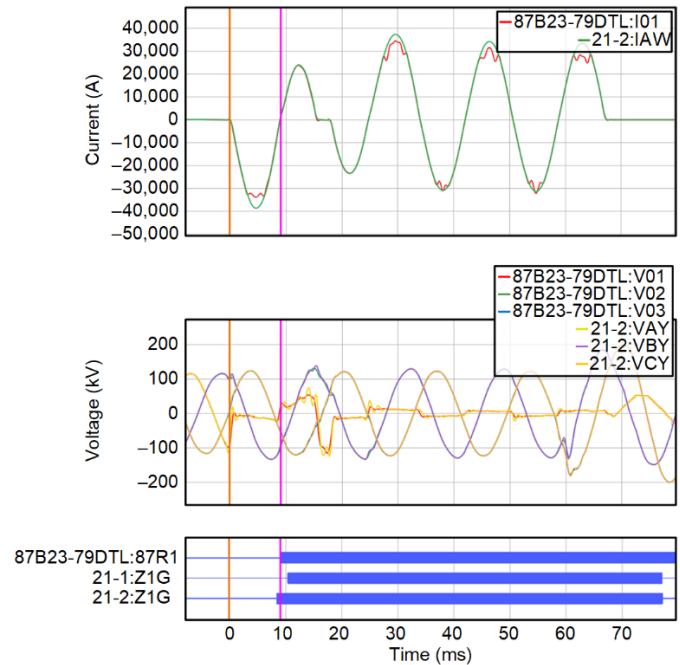
Fig. 4. 21-1, 21-2, and 87B23-79DTL data.

While the 87B23-79DTL relay prevented reclosing, the 21-1 and 21-2 relays issued a breaker trip for the fault and sent GOOSE messages to 50BF-1 and 50BF-2 to operate Breakers 22 and 18. The 21-2 unfiltered analog data and digital data were added to the 87B23-79DTL event to compare the analog data acquisition of a conventional relay (21-2) to the SV relay (87B23-79DTL) as shown in Fig. 4. The digital data from 21-1 was also added. The event report analysis software that was used automatically time-aligns the events based on the trigger time of the event report. Fig. 4 illustrates several key points.

The SV relay automatically compensates for the 1.5-millisecond channel delay for analog quantities when generating the unfiltered event report. This can be thought of as shifting the analog signals 1.5 milliseconds to the left along the x-axis. This allows for direct comparison between the analog signals from conventional relays and from SV relays when doing event analysis.

The digital bits shown are from the filtered event report sampled at the protection and control processing rate of each relay. These event reports contain the precise moment a digital Relay Word bit asserted. Using digital data from the unfiltered event report, which are not sampled at the protection and control processing rate of the relay, can produce a small timing error in Relay Word bits' assertion time. The maximum error when looking at unfiltered event report Relay Word bit assertion time is the time between samples (in this case, 0.5 milliseconds).

The fault arc temporarily extinguishes about 15 milliseconds into the fault. At this point, the current goes to zero and the voltage temporarily recovers for a 2-millisecond duration. The fault arc then reinitiates, once again collapsing the voltage and producing a large amount of fault current. All three relays operate prior to the fault arc temporarily extinguishing. The temporary arc extinguishment could be a result of the pothead explosion creating enough air displacement to temporarily extinguish the arc. Or perhaps a piece of nonconductive material, such as porcelain from the bushing, temporarily interrupted the connection from the energized equipment to ground during the explosion. Regardless of the exact method of arc interruption, we suspect that the explosion of the pothead occurred just after the relays had determined there was a fault and operated.

The 21-2 relay operated in 8.3 milliseconds, the 87B23-79DTL relay operated in 9 milliseconds, and the 21-1 relay operated in 10.3 milliseconds. Relays 21-1 and 21-2 have identical settings. There is a 2-millisecond difference in the conventional relays' operate time. These relays have a protection and control processing rate of 8 samples per cycle, which equates to a 2-millisecond processing interval (PI). It is reasonable to see a difference of 1 PI for operation times.

The A-phase current from 87B23-79DTL, which comes from an MU monitoring CT 3, does not exactly match the current from the conventional 21-2, which gets current directly from CT 3. The disagreement occurs near the peak values of current. It is suspected that the MU at CT 3 did not precisely report the CT 3 current above 50 A secondary. The voltage signals seen in each relay align very closely.

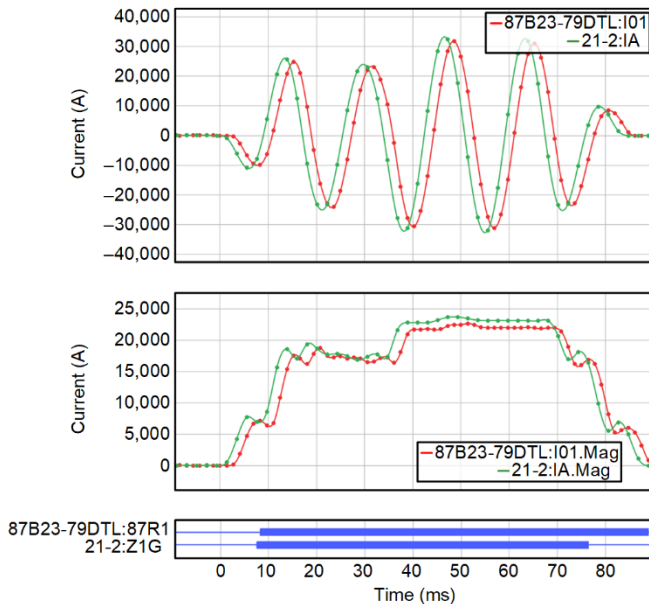
Fig. 5. 21-2 and 87B23-79DTL filtered A-phase current.

To further investigate the effects of the errant MU-produced current from CT 3, we looked at the filtered analog data from each relay. The filtered analog data for the A-phase current of Relays 87B23-79DTL and 21-2, which monitor the same current on CT 3, are shown in Fig. 5.

In Fig. 5, it is clear that the filtered analog signals from the 87B23-79DTL relay do not have the 1.5-millisecond channel delay removed. This is because the analog sample rate used by the conventional relay (i.e., 8 kHz) may be different than the SV relay (4.8 kHz). This means different anti-aliasing filters are used during the downsample process when converting the SV to a filtered value at the PI of the relay. These filter delays vary from relay to relay and cannot be easily accounted for. The current I01 from the 87B23-79DTL relay lags behind the 21-2 relay current, IA. Because of the channel delay, the angular error between the two relays' A-phase current phasor is 32.5 degrees, as shown in (1). However, the overall angular error can differ from (1) due to differences in filtering as previously noted or differences in the tracked frequency between the two relays. Great care must be taken if using

filtered analog data from an SV relay and a conventional relay in event report analysis.

The error in the sampled A-phase current signal produces a lower overall current magnitude reported in the 87B23-79DTL relay. The 21-2 relay reports an A-phase current magnitude of 23 kA, while the 87B23-79DTL reports an overall current magnitude of 22 kA. This equates to a magnitude error of about 4.35 percent. This error is smaller than the 10 percent error we can expect with a well-sized CT during fault conditions [4].

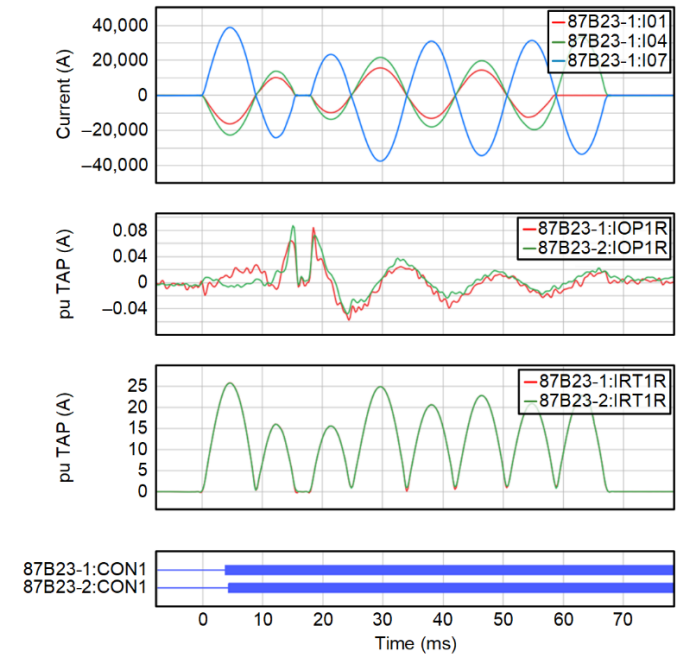
Fig. 6. 87B23-1 and 87B23-2 event data.

The 87B23-1 and 87B23-2 relays correctly restrained for this fault. The event report for both relays is shown in Fig. 6. The unfiltered analog data retrieved from 87B23-1 is nearly identical to 87B23-2, so we show only the current data from 87B23-1 (top graph). In the second and third graphs, we show the unfiltered time-domain-based operate and restraint currents for each relay. The Relay Word bit 87B23-1:CON1 is the external fault detector (EFD) from 87B23-1 and the Relay Word bit 87B23-2:CON1 is from 87B23-2. Both relays correctly identify this as an external fault.

The current 87B23-1:I07, shown in Fig. 6, which is from CT 1, is the same as the current seen by the 21-1 (CT 4) and 21-2 (CT 3) relays except that the polarity is opposite. This is expected due to the connected CT polarity of the relays.

The time-domain-based IOP (IOP1R) and IRT (IRT1R) values in Fig. 6 are nearly identical between the two relays. The time-domain operate current, which is the addition of all the unfiltered current signals, is near zero throughout the entire event since all current is flowing through the zone of protection, not into the zone of protection. The time-domain restraint current, which is the addition of the absolute value of all the unfiltered current signals, increases rapidly at fault inception.

The 87B23-1:CON1 Relay Word bit asserts in 3.73 milliseconds from fault inception and the 87B23-2:CON1 Relay Word bit asserts in 4.33 milliseconds from fault inception, as shown in Fig. 6. This means the SV relay was only 0.6 milliseconds slower than the conventional relay at detecting an external fault.

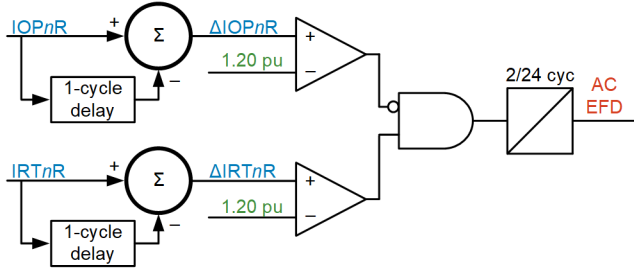
Fig. 7. EFD in 87B23-1, 87B23-2, and 87B23-79DTL relays.

A simplified logic diagram for the EFD is shown in Fig. 7.

The EFD is used to add security to the differential protection by quickly determining if the fault is within the zone of protection before the effects of CT saturation diminish relay security [5]. For an external fault, we expect the restraint current to increase but the operate current to remain at zero. If the change in restraint current over the course of 1 cycle ($\Delta IRT1R$) is high, and the change in operate current over the course of 1 cycle ($\Delta IOP1R$) is low, the relay declares the fault external after 2/24 cycles (1.389 milliseconds). It is important to note that the $\Delta IOP1R$ and $\Delta IRT1R$ signals are generated from unfiltered time-domain signals, not the filtered phase-domain values. Because of this, accurate reproduction of the current signals is very important at fault initiation for the relay to operate properly.

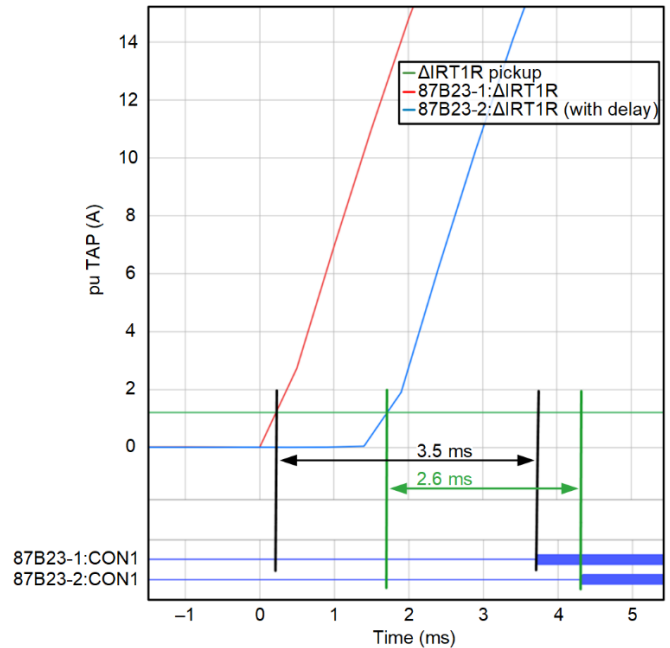
Fig. 8. 87B23-1 and 87B23-2 CON bits.

Fig. 8 shows the $\Delta IRT1R$ signals for 87B23-1 and 87B23-2 compared to the 1.2 pu threshold. We did not plot $\Delta IOP1R$ as it was apparent from Fig. 7 that it would not exceed the 1.2 pu threshold. The automatic 1.5-millisecond analog channel delay compensation provided by the relay in the unfiltered event is manually removed from 87B23-2 by shifting the signal 1.5 milliseconds to the right along the x-axis. The black cursors show the moment at which the 87B23-1 relay $\Delta IRT1R$ signal is above 1.2 pu and the moment when the logic in Fig. 7 times out (3.5 milliseconds). The green cursors show the moment at which the 87B23-2 relay $\Delta IRT1R$ signal is above 1.2 pu and the moment when the logic in Fig. 7 times out (2.6 milliseconds).

The two relays do not have their PIs in sync, so there are some discrepancies between this time differential (0.9 milliseconds), and the true operation time differential (0.6 milliseconds). This figure illustrates that it is possible for the time differential between the operate time of a conventional and SV relay to be shorter (or longer) than the channel delay setting. This is due to slight variations in the PI that each relay provides the Relay Word bit output.

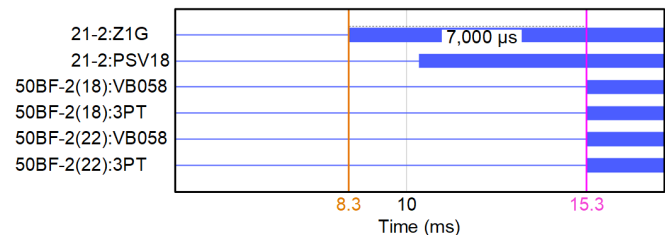
Fig. 9. Delay from relay operation to breaker trip signal.

Fig. 9 shows the assertion of Z1G in the 21-2 relay and the three-pole trip signal (3PT) that is issued at 50BF-2 for Breaker 18 (50BF-2(18):3PT) and Breaker 22 (50BF-2(22):3PT). In each breaker relay, a three-pole trip is initiated via Virtual Bit 58 (VB058). There is a 7-millisecond time delay between the relay declaring a fault and the breaker relay issuing a trip.

We note that 2 milliseconds (1 PI for the 21-2 relay) can be saved from the overall trip time if intermediate logic (PSV18) was not used to send the GOOSE message to the 50BF-2 relay. ComEd uses relay logic for GOOSE message bit transmission to maintain a uniform naming convention for all Manufacturer A relays on their system.

The remaining 5-millisecond delay is from publishing the GOOSE message on the network, transmitting the GOOSE message over the network, and processing the GOOSE message at a subscribing relay. Since this event, advances have been made in GOOSE message processing for relay virtual bits that can further reduce operate time [3].
